LINDENWOLD PUBLIC SCHOOLS JIF Annual Mold Seminar

indenwold Public School District 7/14/2021

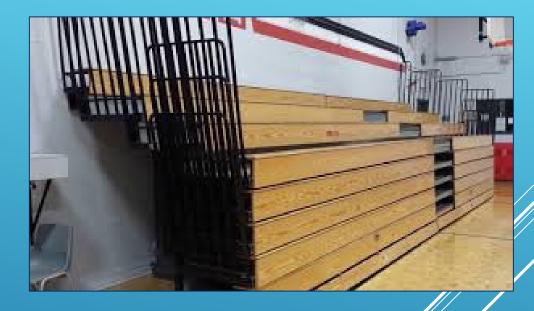
HIGH SCHOOL GYM BLEACHERS – ONE & DONE

- Custodians had cleaned the bleachers using water based solution
- HVAC system was not working properly – dehumidification not working
- Bleachers were pushed into the wall after cleaning - preventing air flow

- Mold claim process must notify our environmental carrier first
- Must use a CIH and follow their protocol for clean up – failing to do this can disqualify your costs for coverage
- We needed to better train employees and enhance our cleaning protocol to eliminate issues like this in the future
- ▶ What not to do for next year's back to school night©

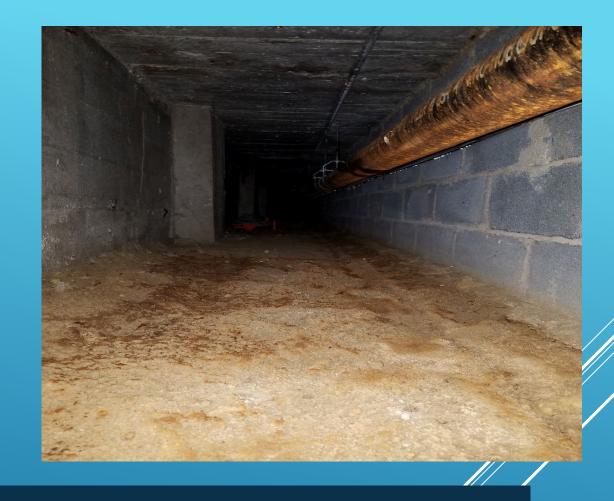
MIDDLE SCHOOL CRAWL SPACE SYSTEMIC & NEEDS A LONG TERM SOLUTION

- ► Lindenwold Middle School built in 1939
- Dirt floor crawl space under the entire original building
- Originally heated with steam piping
- ► Large HVAC project in 2015 which created many penetrations in first floor classrooms for piping
- Humidity very high in certain classrooms water resting on top of unit ventilators, unidentified "puddles"

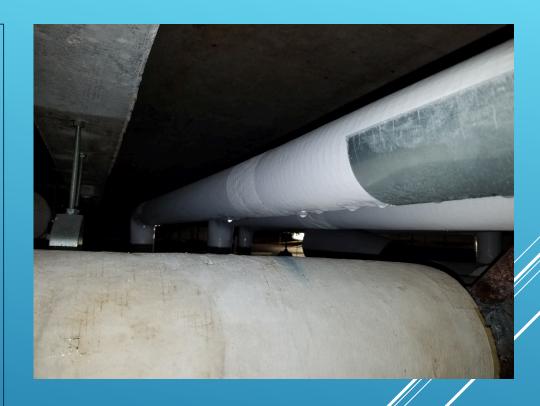
MIDDLE SCHOOL CRAWL SPACE SYSTEMIC & NEEDS A LONG TERM SOLUTION

- Relied on internal protocols for IAQ inspection and documentation
- Performed internal investigation of crawl space as it was the only viable solution for the source of water
- ► Found the open penetrations in classroom floors and the humidity created by very old leaking steam pipes
- Sealed the penetrations to solve the classroom humidity but then contacted JIF environmental carrier to further investigate the crawl space situation
- ► Long term solution was engineered to create a negative pressure environment in the crawl space using fans simple design solved a big problem
